# NATIONAL TRANSPORTATION SAFETY BOARD

## MATERIALS LABORATORY FACTUAL REPORT

Report No. 08-132

Place : Phoenixville, PA  
Date : 9/7/2008  
Vehicle : Lindstrand Balloon  
NTSB No. : NYC08FA307  
Investigator : Shawn Etcher

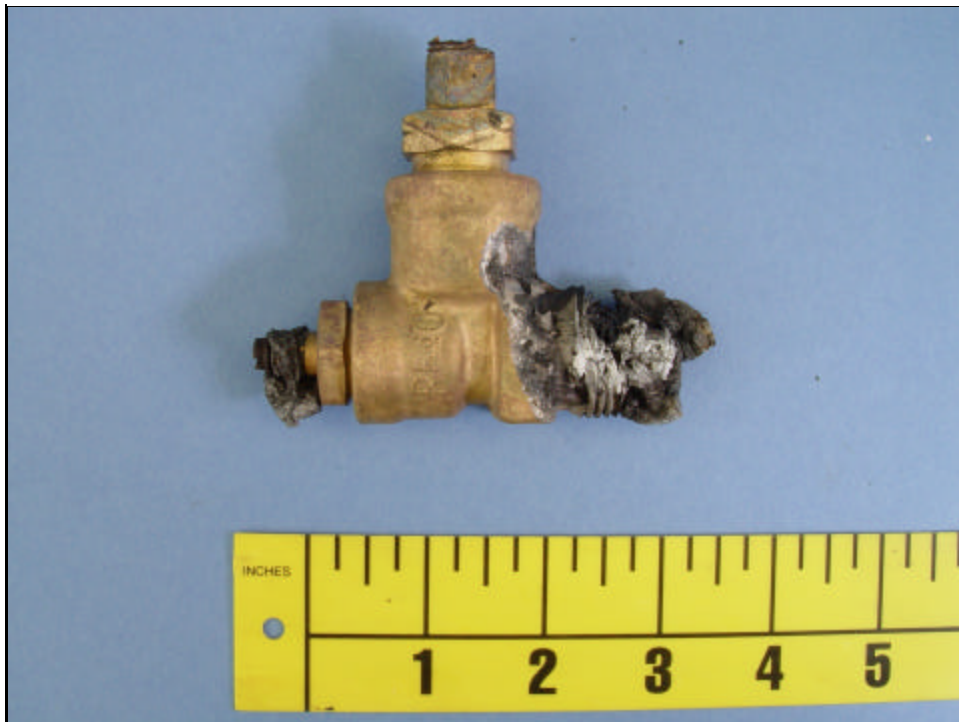
The following is a description of the components in the delivery system starting with the control valve and continuing on to the respective components in the direction of fuel flow. The tank valve, as shown in Figure 1, was a Rego brand 9101C1 tank valve. Energy dispersive spectroscopy (EDS) analysis determined that the composition of valve body material was consistent with brass. The valve exhibited evidence of exposure to fire. The valve handle stem was found to be in the "off" position, although the handle itself had melted off. The male end of the valve was covered in a melted metallic material consistent in appearance with melted aluminum.

Figure 1. Fuel control valve.

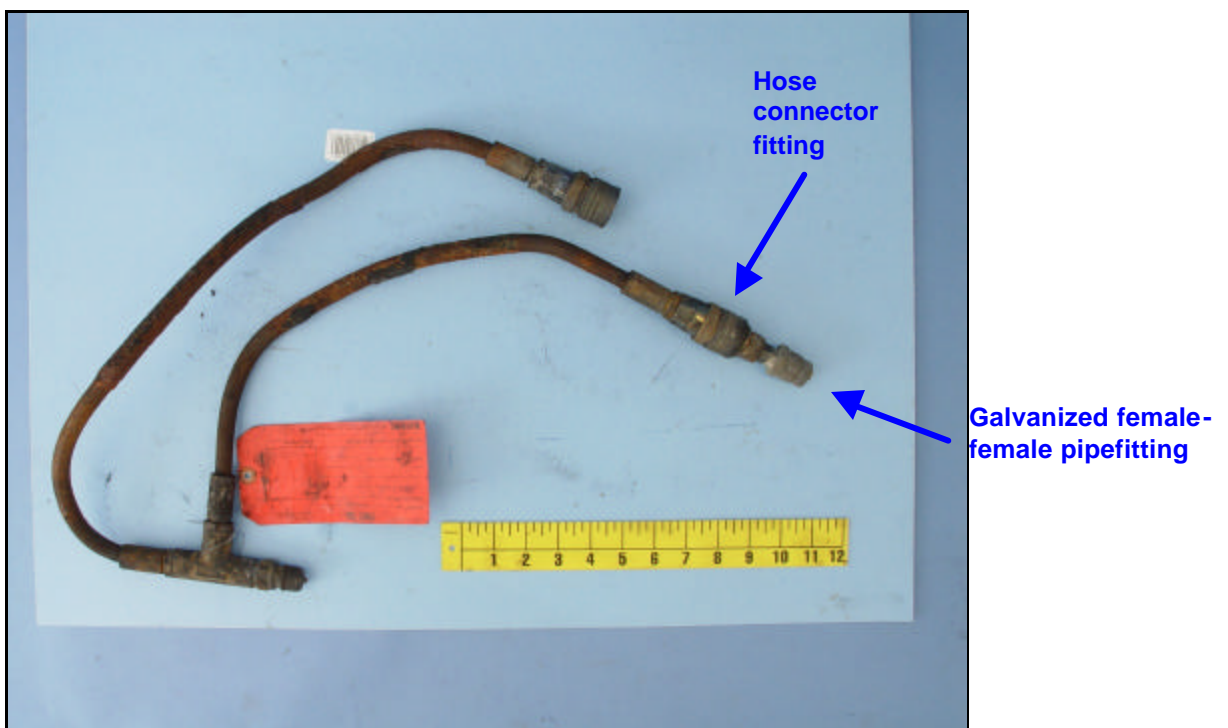
heavily charred and sooted. No other testing or examination was done on the fuel hoses due to the heavy fire damage.

Figure 2. Fuel delivery lines.

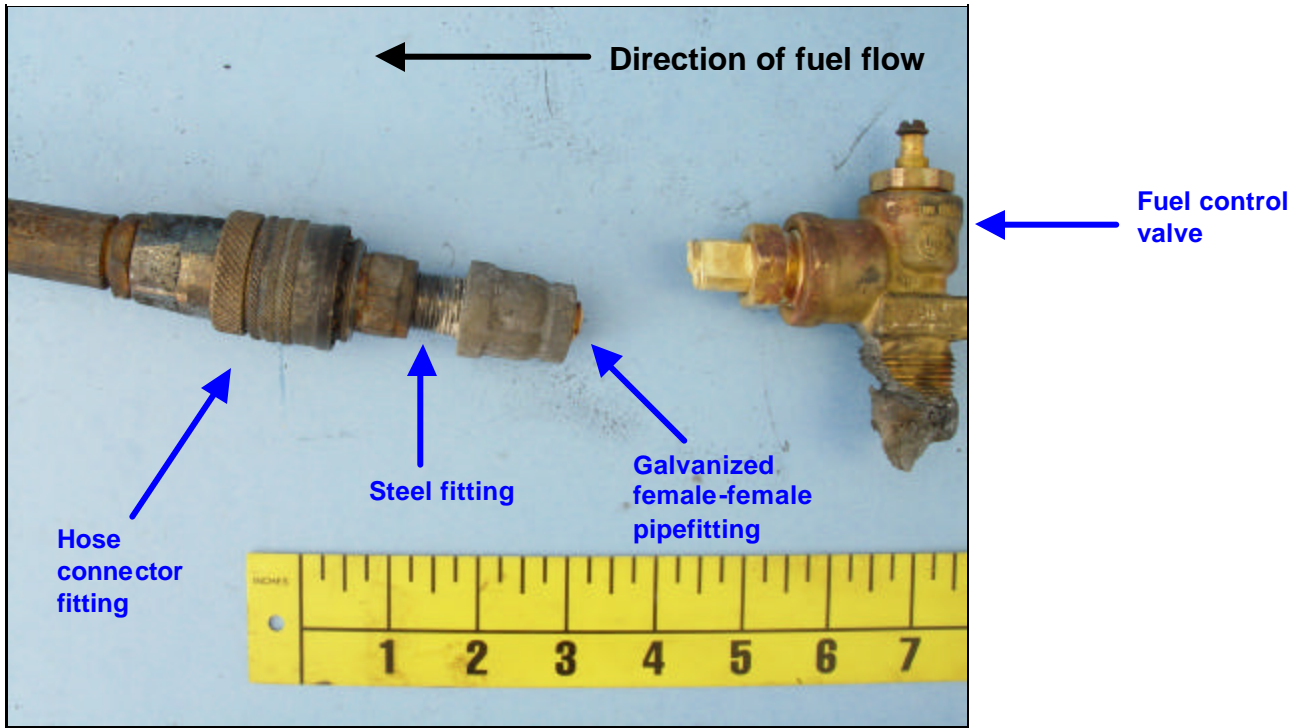
Another brass fitting was found attached to the female end of the valve. The end of the fitting was fractured. SEM examination of the fracture surface found microvoid coalescence fracture features consistent with overstress. The other end of the fractured brass fitting was attached to a female-female fitting, shown in Figure 3. EDS analysis determine this fitting to be galvanized steel often used in pipe or plumbing fittings. This fitting was attached to another steel male nipple fitting, attached to quick-release hose fitting that was attached to the fuel delivery hoses as shown in Figure 2. All of the fittings had some degree for fire related damage such as surface changes to the metal and sooting. The fuel hoses were heavily fire-damaged. The steel braiding was the only intact layer found. A majority of outer and inner sleeves were missing and presumed to have been burned away. The remaining pieces were

Figure 3. Fuel control valve and associated fittings.
